Ground Improvement Reinforcement Mechanisms Determined for the Mw7.8 Muisne, Ecuador, Earthquake

Miriam E. Smith, Ph.D., P.E.¹; and Kord J. Wissmann, Ph.D., P.E., D.GE²

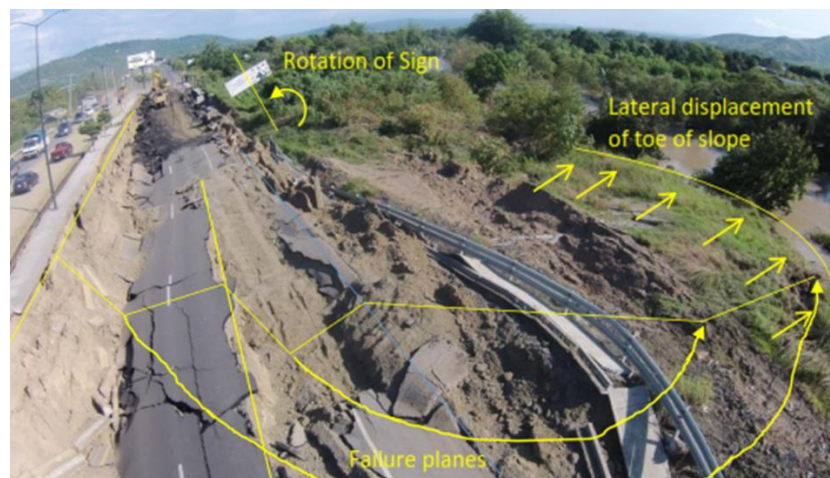
Mejia Bridge: One such site that experienced devastating effects from the earthquake is the Mejia Bridge site, which was 78 km from the epicenter and where peak ground accelerations of 0.32 g were recorded. The subsurface conditions beneath the Mejia Bridge unsupported approach embankments generally consist of loose to medium dense silty and clayey sands with interbedded layers of medium dense gravel and sandy clay. A post-earthquake photo of the unsupported (no ground improvement) Mejia Bridge is provided in Figure 1. The sketches on Figure 1 were provided in the *GEER-ATC Earthquake Reconnaissance* report, which states that the failure surface “may be due to liquefaction-induced softening that allowed the reduced-strength soil to shear during the earthquake” (Nikolaou et al. 2016).

Figure 1. Mejía River Bridge Unsupported Approach Embankment (Nikolaou et al. 2016).

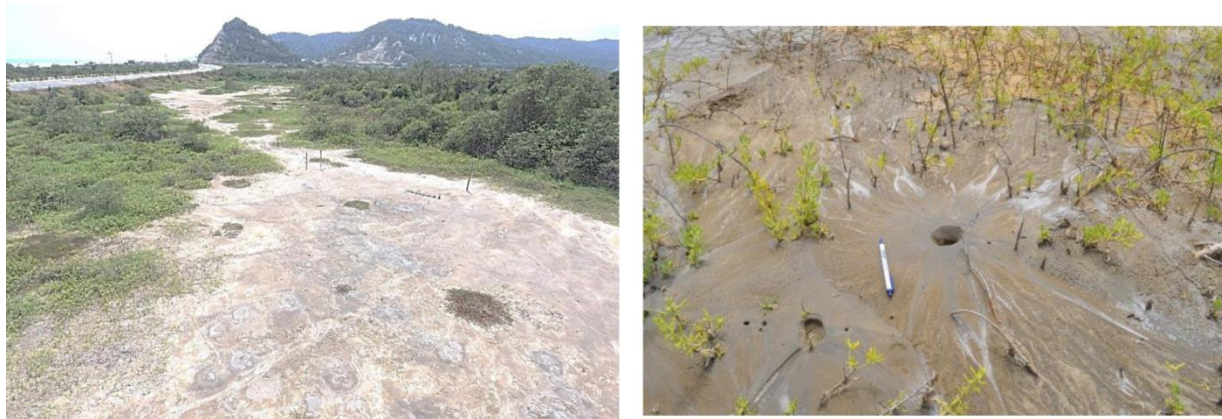
Figure 3. Sand boils indicative of liquefaction at the Boca de Briceño Bridge site (courtesy of X. Vera-Grunauer)

During the GEER-Earthquake Reconnaissance, evidence of liquefaction was observed within meters of the embankment in the form of sand boils and sand ejecta through cracks in the ground adjacent to the bridge abutment (Figure 3). However, the embankment exhibited minimal

that indicate the foundation soils liquefied (Figure 3).

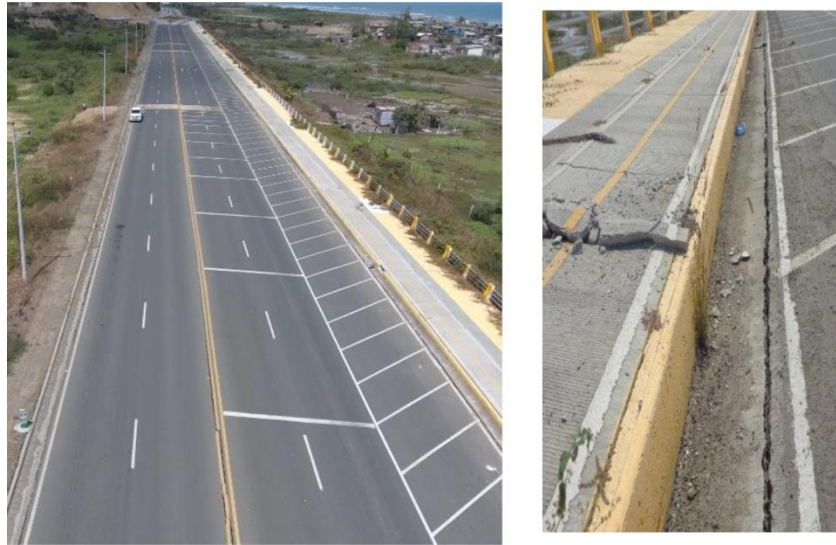
damage while maintaining the serviceability of the road to the public (Figure 4).

Figure 4. Minor repairable post-earthquake damage at the RAP-supported Briceño bridge embankment (courtesy of X. Vera-Grunauer)

The CPT data measured beneath the embankment in the RAP-reinforced zone (plotted as circles on Figure 5) was also converted to a residual shear strength. Using this shear strength beneath the embankment footprint, factor of safety against stability increased to 1.08, which demonstrates some improvement due to densification of the matrix soil but likely not enough to prevent large deformations experienced by the embankment. The Briceño embankment experienced minimal damage following the Muisne earthquake (Figure 4) despite the sand boils

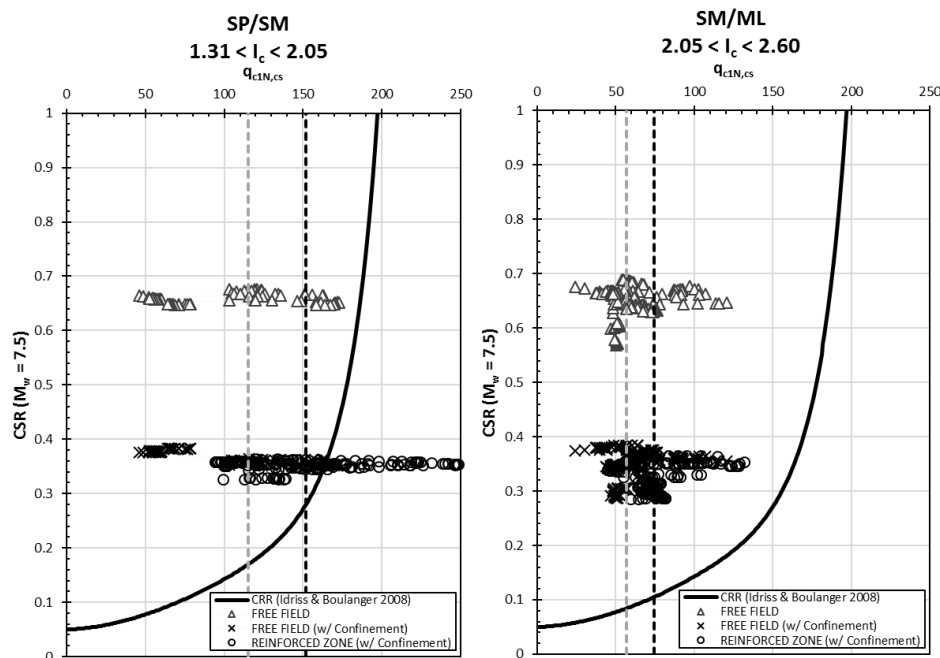
For the Briceño bridge site, corrected CPT tip resistance values ($q_{c1N,cs}$) within the liquefiable layer vs. the calculated Cyclic Stress Reduction (CSR) are presented in Figure 5 for each of the predominant soil classifications. The interbedded layers were separated based upon the measured soil behavior index (I_c). The free field data (triangles) plots left of the CRR line (as determined based on Idriss and Boulanger 2008) indicating liquefaction was triggered in the liquefiable layer. The calculated factors of safety against liquefaction in the SP/SM and SM/ML materials are approximately 0.27 and 0.12, respectively. These values are corroborated by the sand boils and ejecta documented outside the footprint of the Briceño bridge embankment. The values of CSR for the free-field conditions were also calculated by taking in to account the overburden stress of the embankment (i.e. confinement). These corrected values of CSR are also plotted on Figure 5 (crosses), where it can be seen that about 90% of the data points for the SM/ML and 100% of the data points for the SM/ML soils are predicted to liquefy. This suggests that confinement alone did not prevent liquefaction in the liquefiable soils.

Measured and corrected CPT tip resistance values beneath the center of the embankment within the RAP-reinforced zone are also plotted in Figure 5 (circles). The data shows an increase

in CPT tip resistance due to densification in the SP/SM soils. Due to densification alone, about 50% of the data points in the SP/SM soils move to the right of the CRR line, indicating a factor of safety against liquefaction greater than 1.0 for these points. Only minor densification is measured in the SM/ML soils, indicating that the factor of safety against liquefaction for these soils remains less than 1.0.

The data presented in Figure 5 suggests that the combined benefits of increased confinement and increased densification of the soil matrix are not sufficient to preclude liquefaction below the embankment during the design earthquake.

Figure 5. CPT data vs. CSR for the Briceño Bridge site

Using the CPT data from Figure 5 (plotted as triangles), the residual shear strength of the liquefiable layer in the free field was evaluated using Equation 1. A pseudo-static ($k_h = 50\%$ of the design $PGA=0.40\text{ g}$) limit equilibrium stability analysis of the Briceño embankment was performed using the free field residual shear strength of the liquefiable layer beneath the entire
